Competition Launch Control System

Flickering Continuity Indicator Investigation

PITTSBURGH SPACE COMMAND

October 2024

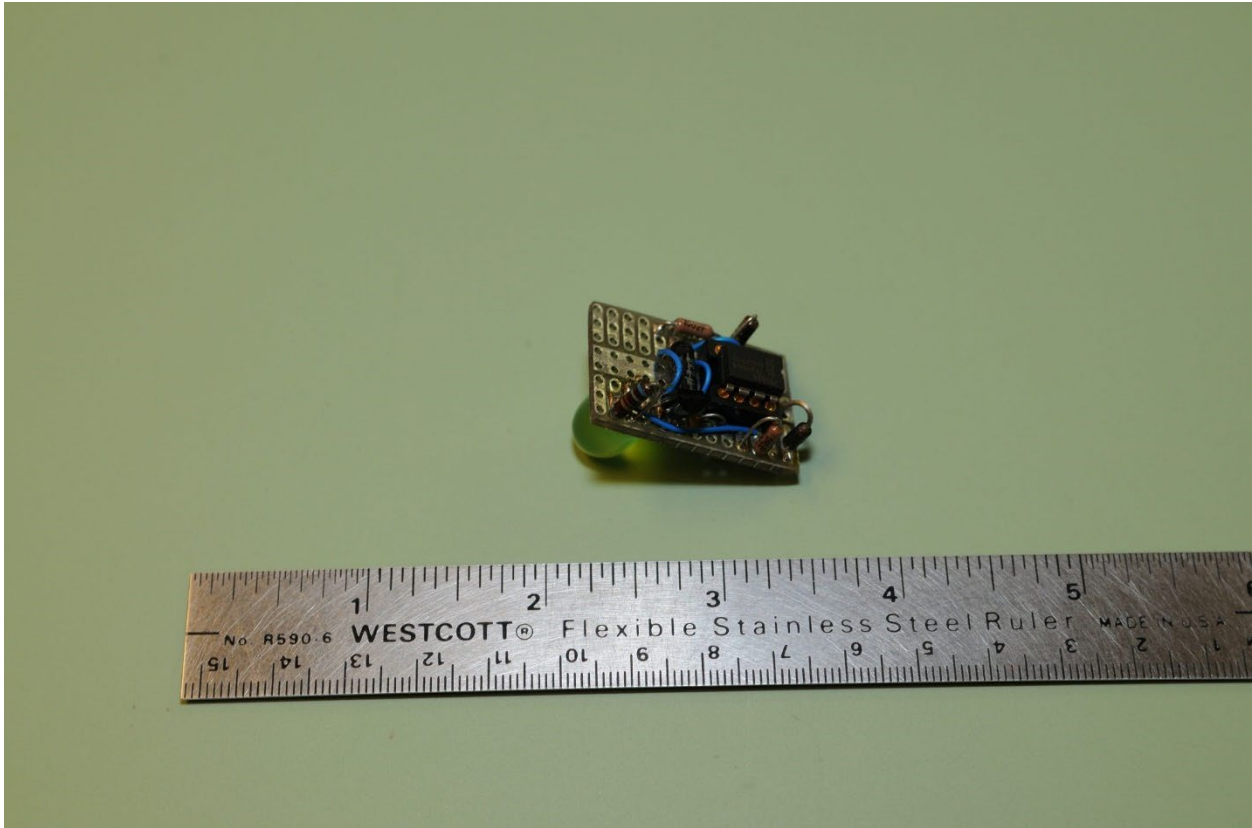
Old Pad Safe Indicator Board

There were two problems with the old Pad Safe Indicator circuit – first, the LED indicator was a low brightness Green LED, and it was hard to see from the LCO desk. Second, and more problematic, the Pad Safe board would fail at virtually every launch. The way it was designed to interface with power left it exposed to inductive kickback from the relays, and the timer circuit would eventually fry. So I took Tim’s timer circuit design as it was, but added some power protection and corrected the way it interfaced to power. I also replaced the old Green LED with a new, high brightness Blue LED. With these changes the Pad Safe Indicator is now easily visible from the LCO location and we haven’t had a failure since.

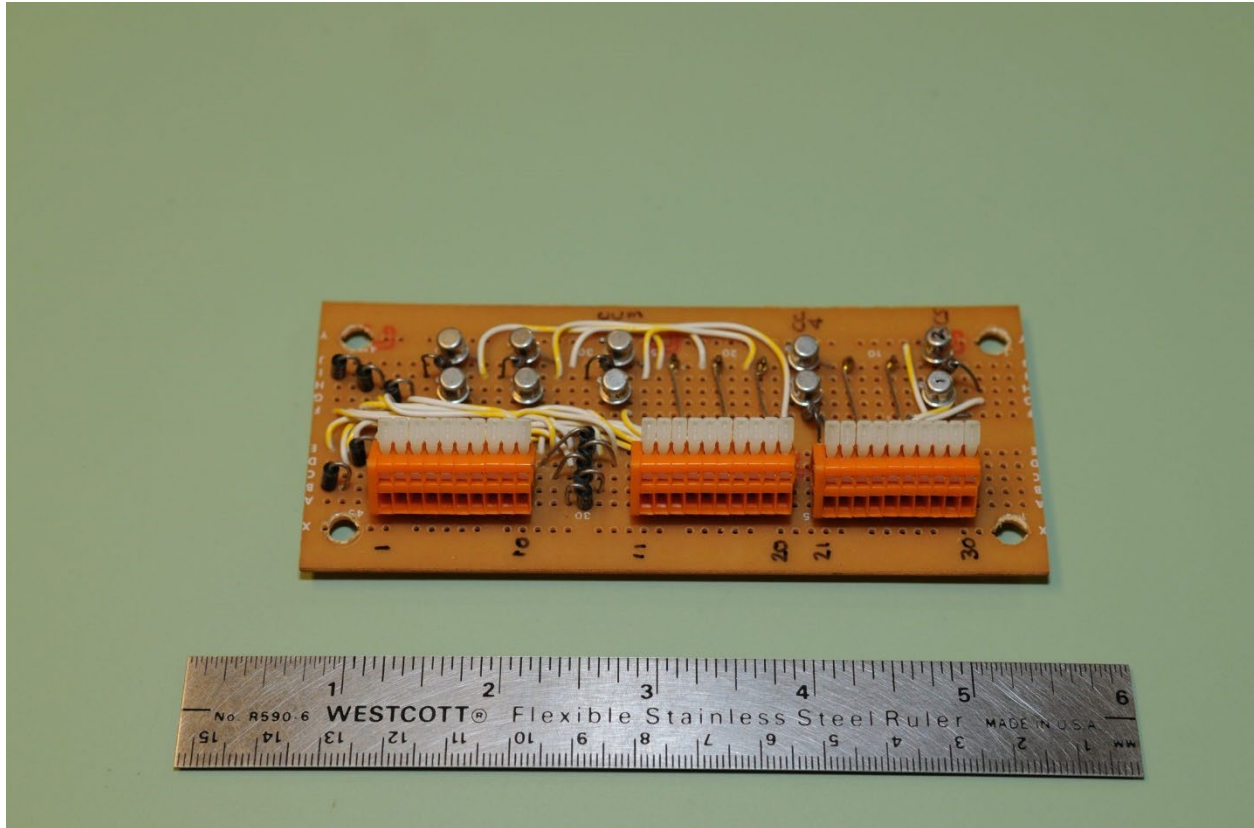
Old Continuity Board

Tim's continuity check circuit is an elegant design; its concept relies on the use of a transistor as the check current source. Doing so allows one to reduce the check current to very low levels, an important consideration when the system could be confronted by all kinds of igniter types, from high current Aerotech First Fires to Quest Q2G2s and electric matches. As originally designed by Tim, the check current was limited to 1.2mA; compare this to a typical Estes Electron Beam controller with the old incandescent continuity check bulb: that controller passes a 200mA check current.

The check circuit was duplicated on the board for each of the pads; each circuit consisted of two transistors – one to drive the Continuity Indicator back on the LCO Console, and one to drive the local continuity LED on the front panel of the Yellow Box. Looking at the photo of the Old Continuity board, one can see a total of five pairs of transistors, one pair assigned to each pad.

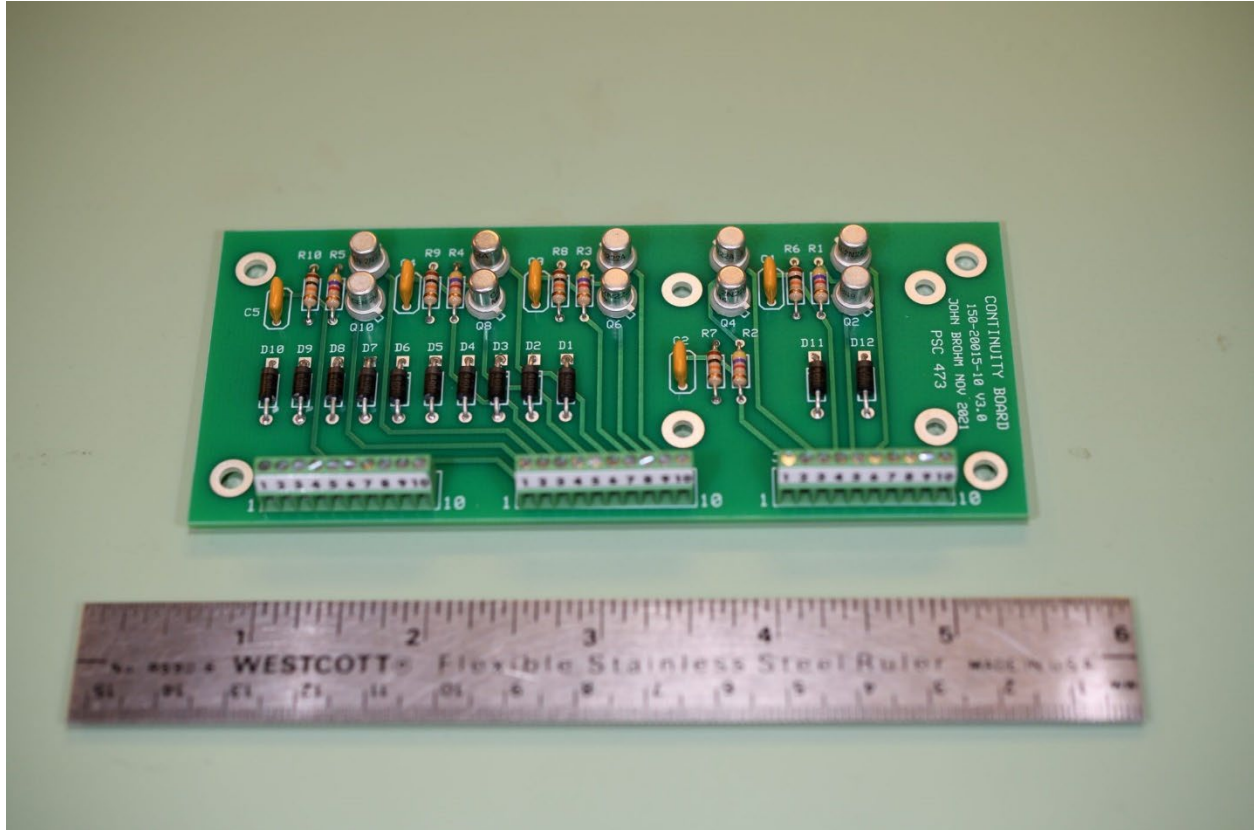
New Continuity Check Board

When I refurbished the Yellow Box, I took the opportunity to layout Tim's continuity circuit on a new PCB. I also made a couple of adjustments to the circuit. As we'll see in the schematic provided later on in this note, I added a pull-down resistor to the input of each transistor pair. Even though Tim's circuit usually worked properly, his design left these inputs floating when an igniter wasn't present in the circuit. Under the right temperature and humidity conditions, this can cause the transistors to pass a small leakage current, giving rise to a faulty continuity indication. Adding an input pull-down resistor ensures each transistor pair is fully turned off when the corresponding pad isn't active/enabled.

I also reduced the value of the check current limiting resistor. Tim's design produced a check current of 1.2 mA; this in turn was split between the two transistors comprising each pair – a somewhat marginal arrangement. I wanted to make sure that when turned on, each transistor was saturated; that would ensure

the transistors would be fully "ON". Reducing the check current limiting resistor value ensured the transistors were biased for this operating mode. These changes increased the check current to 3.5mA.

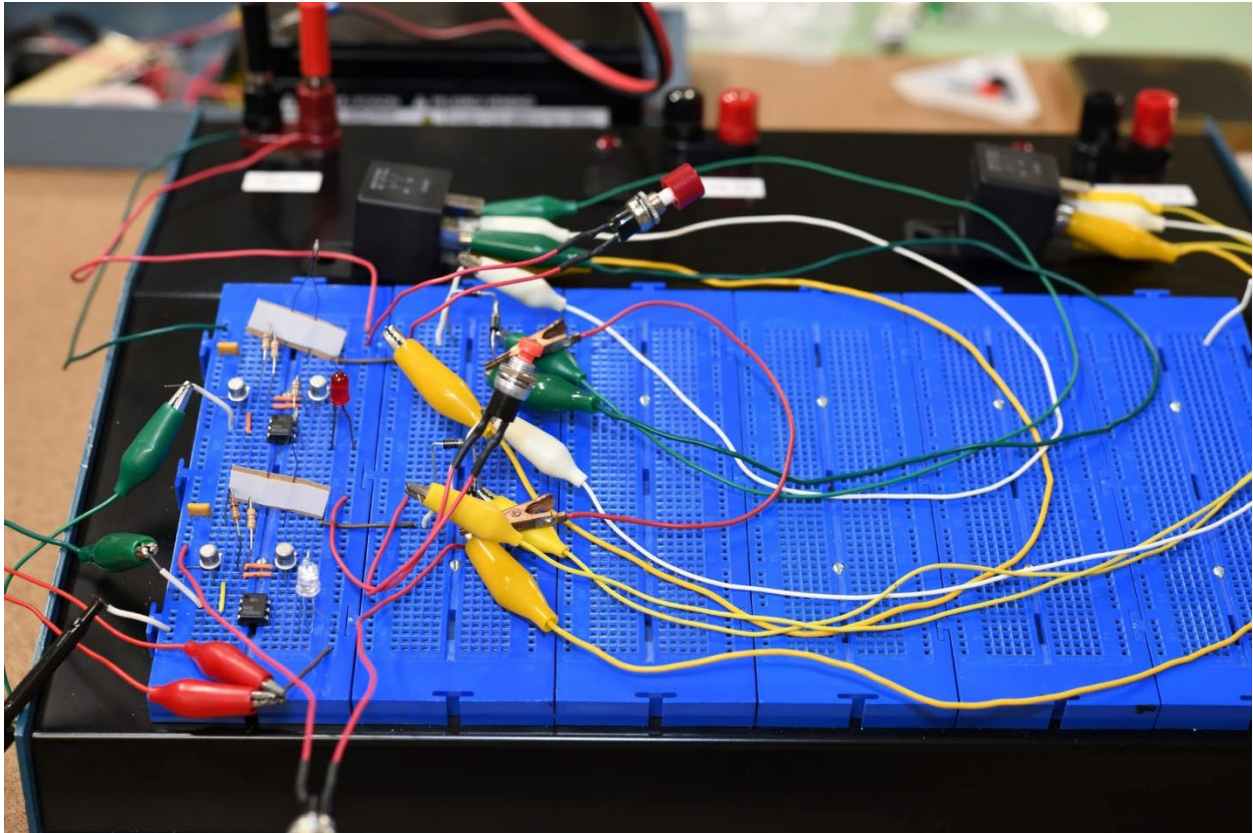
Breadboard Test Circuits

Back when the problem was first noticed, I set up a pair of continuity circuits on my breadboard so they could be tested and experimented with. The following photo shows the setup. There are two circuits on the breadboard, let's call them Pad 1 and Pad 2, and the circuits include both an LCO Continuity indicator and a Local Continuity indicator. I used the exact same LCO indicators as installed in the console; they are sitting on the left, just outside of the photo.

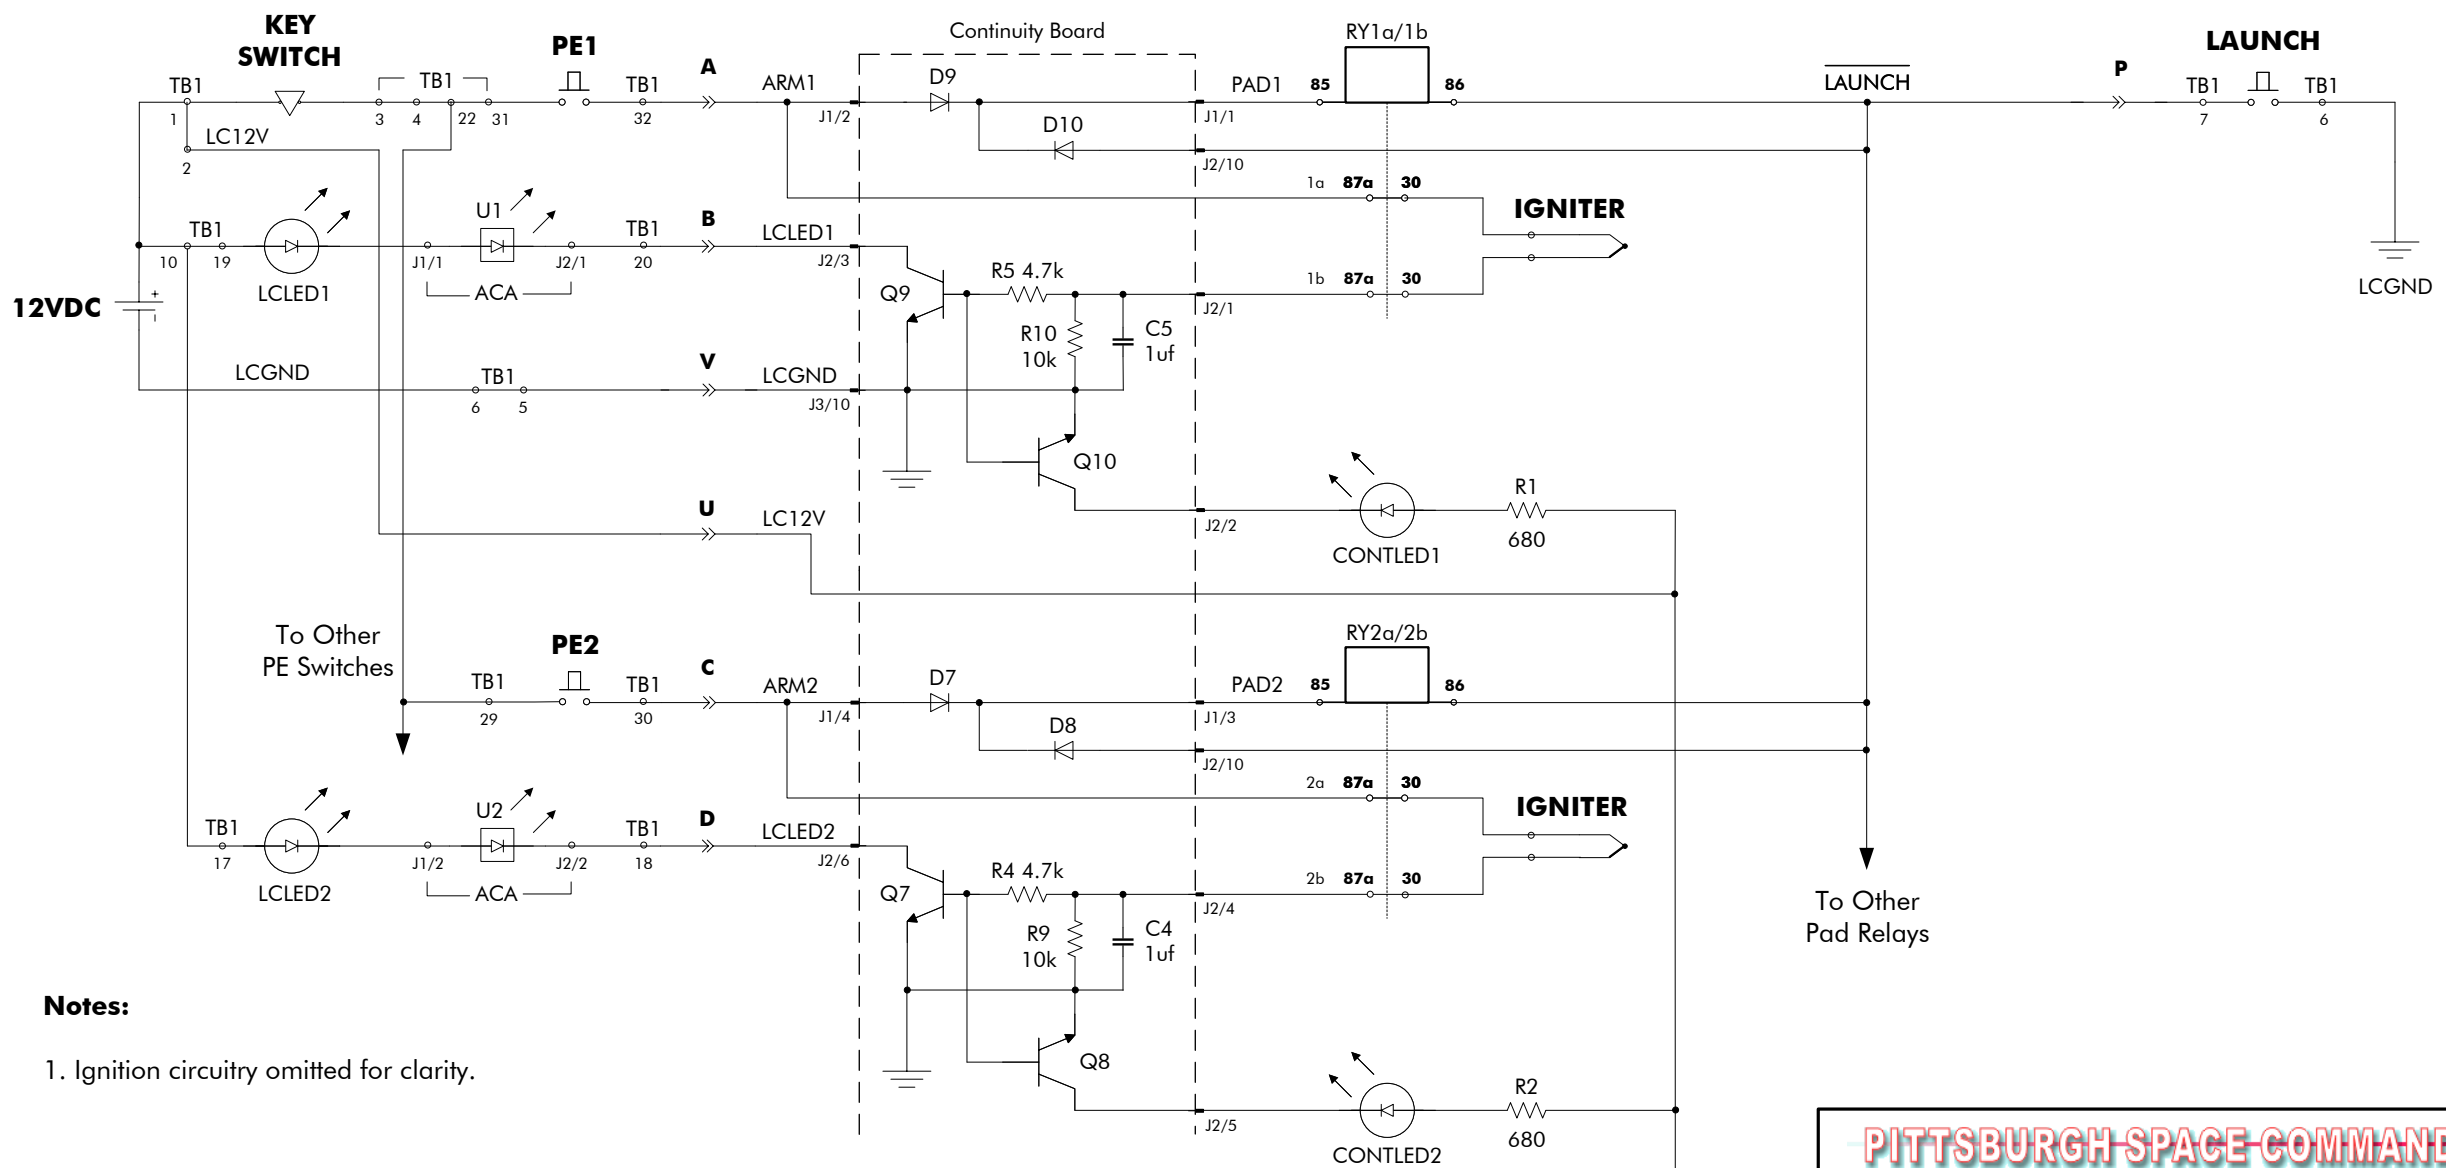
Continuity Check & Indication Circuits

With the circuits powered up and igniters connected, what I found was that indeed, pressing the Pad Enable (PE) pushbutton for, say, Pad 1 would fully illuminate the continuity check indicator for Pad 1, but would also cause a momentary, dim pulse or flash to occur on the indicator for Pad 2. The same would occur in reverse, that is, if I pressed the PE for Pad 2 – a momentary pulse would show up on Pad 1's Continuity Indicator.

But what about the adjacent indicator flickering problem? To get a better idea of the effect, I configured the continuity circuit on my breadboard exactly as Tim originally had it – no damping capacitors (C4/C5 removed), no input pulldown resistors (R9/R10 removed), and the check current limiting resistor value restored to the original 10k ohms that Tim had (R4/R5). In this configuration I found the adjacent indicator flickering to be even more pronounced/more visible than what I had observed before I added the pulldown resistors and the damping capacitors. I also observed the flickering occurring with the associated local Yellow Relay Box continuity indicators as well.

I then removed the common return LAUNCH line between relays. No flickering. I reconnected the common return but removed the igniter from the adjacent circuit; again, no flickering. Reconnecting everything and the adjacent indicator flickering returned once a PE button was pressed. So even though the blocking diodes were stopping any kind of significant reverse current, the presence of the common return was still providing some kind of electrical path for this issue.

The importance of pulling D9 must be underscored; doing so completely isolated the PAD1 continuity check circuit. PE1 was open, and removing D9 removed the electrical path through RY1. Yet pressing PE2 would cause LCLED1 to flicker. Things were now pointing to the relay itself.

So next, I pulled the wire that connected the igniter to relay contact 30. No flicker. I replaced this wire and then pulled the wire from relay contact 87a to D9. The flicker returned. Now the problem was localized.

The investigation implicates the relays themselves as the source of the momentary pulse that causes the flicker to occur. But as the relays are open ended when not selected (supposedly electrically isolated), how can this happen? Well, what the testing implies is that when igniters are hooked up and a pad is selected (i.e.: a continuous circuit), let's say PE2 is pressed, the 12V battery potential is immediately connected through D7 and the relay coil in RY2 to the common return line. That sudden rise in potential also lands at the back end of the relay coil in RY1, and like any inductor (which is what the relay coil is) that sees a sudden rise in voltage, it generates a brief spike which in turn is inductively coupled to the relay contacts, given their close proximity with the relay package. It's a very brief and very small spike, and very little in the way of an actual induced current, but the induction is enough to ripple a spike to the input of the Q9/Q10 transistor pair.

My immediate thought was perhaps there was some kind of inductive kickback or pulse occurring from the relays, causing a brief pulse to leak through to the transistor inputs. I experimented with several values of input damping capacitors and found that a $1\mu\text{f}$ capacitor placed at the input of each transistor check circuit would damp out the pulse. No more flickering. I updated the PCB layout to include these capacitors, soldered up a new board, and that's the one you see in the earlier photo. The added capacitors are the small yellow rectangular components located beside each set of resistors and transistors.

I found that adding the 10k pulldown resistor back in to the input circuit reduced the intensity of the flicker; adding the damping capacitor eliminated the problem entirely. The damping capacitor acts like a short circuit to a sudden short duration spike, so the spike never gets to the transistors, thus eliminating the flicker.
