Competition Launch Control System

Flickering Continuity Indicator Investigation

PITTSBURGH SPACE COMMAND

October 2024

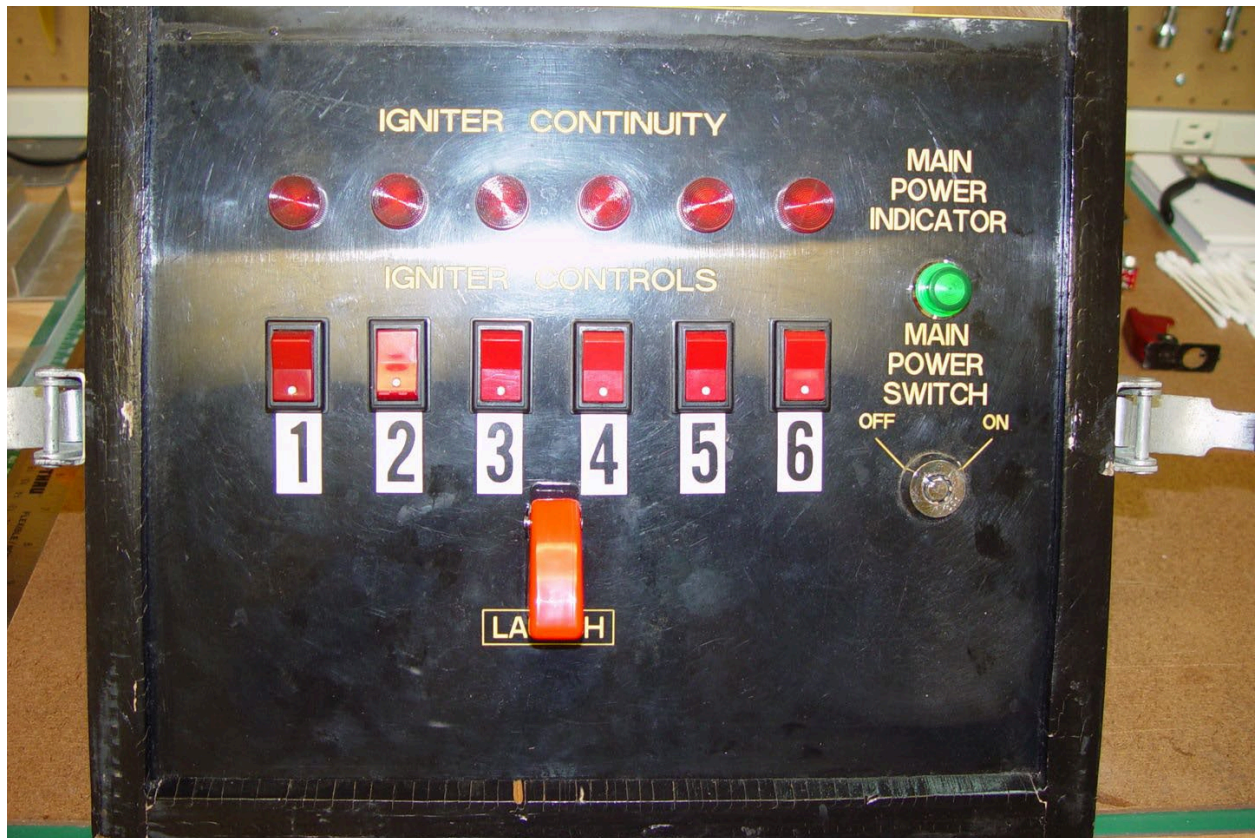
Old Control Console

It featured some very hard to see incandescent bulb continuity indicators, some Pad Select rocker switches that could be inadvertently left in the "ON" position, and a momentary toggle switch that was used as the launch button.

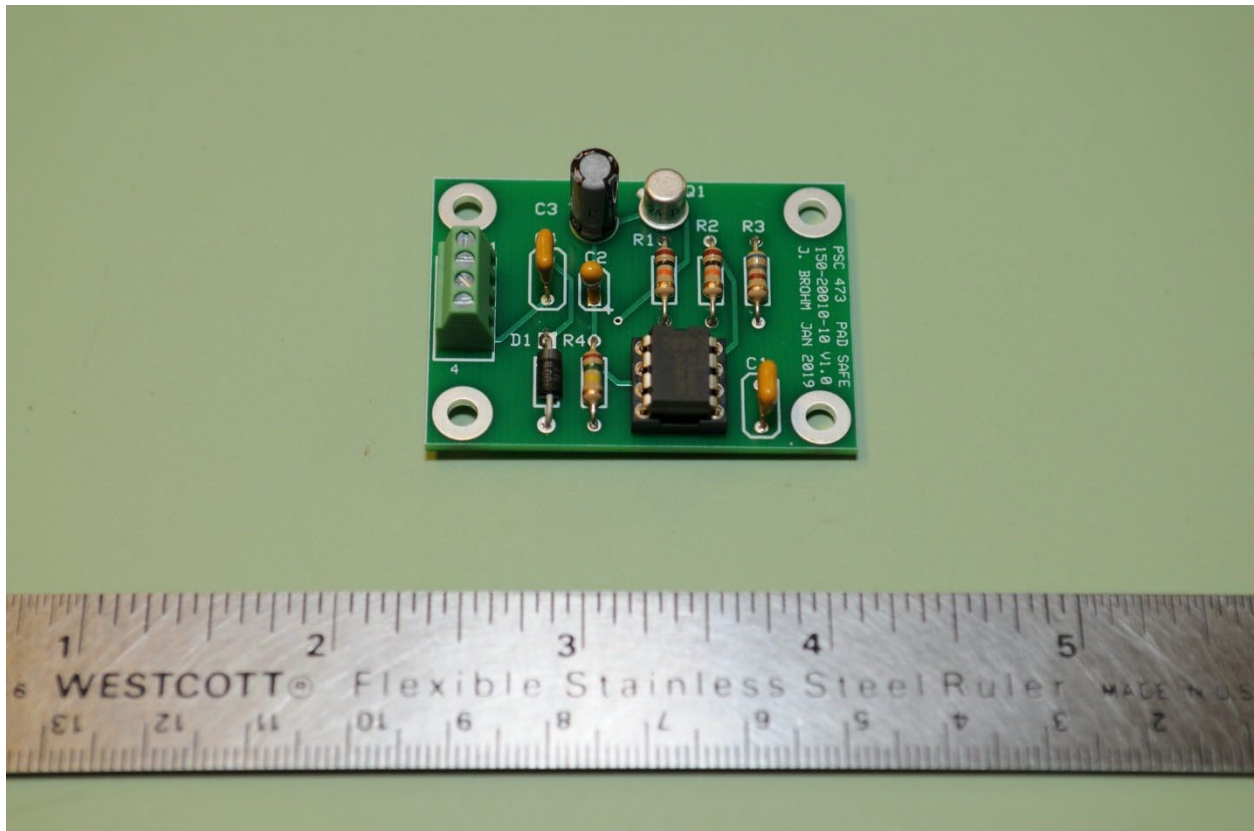
New Pad Safe Board

There were two problems with the old Pad Safe Indicator circuit – first, the LED indicator was a low brightness Green LED, and it was hard to see from the LCO desk. Second, and more problematic, the Pad Safe board would fail at virtually every launch. The way it was designed to interface with power left it exposed to inductive kickback from the relays, and the timer circuit would eventually fry. So I took Tim’s timer circuit design as it was, but added some power protection and corrected the way it interfaced to power. I also replaced the old Green LED with a new, high brightness Blue LED. With these changes the Pad Safe Indicator is now easily visible from the LCO location and we haven’t had a failure since.

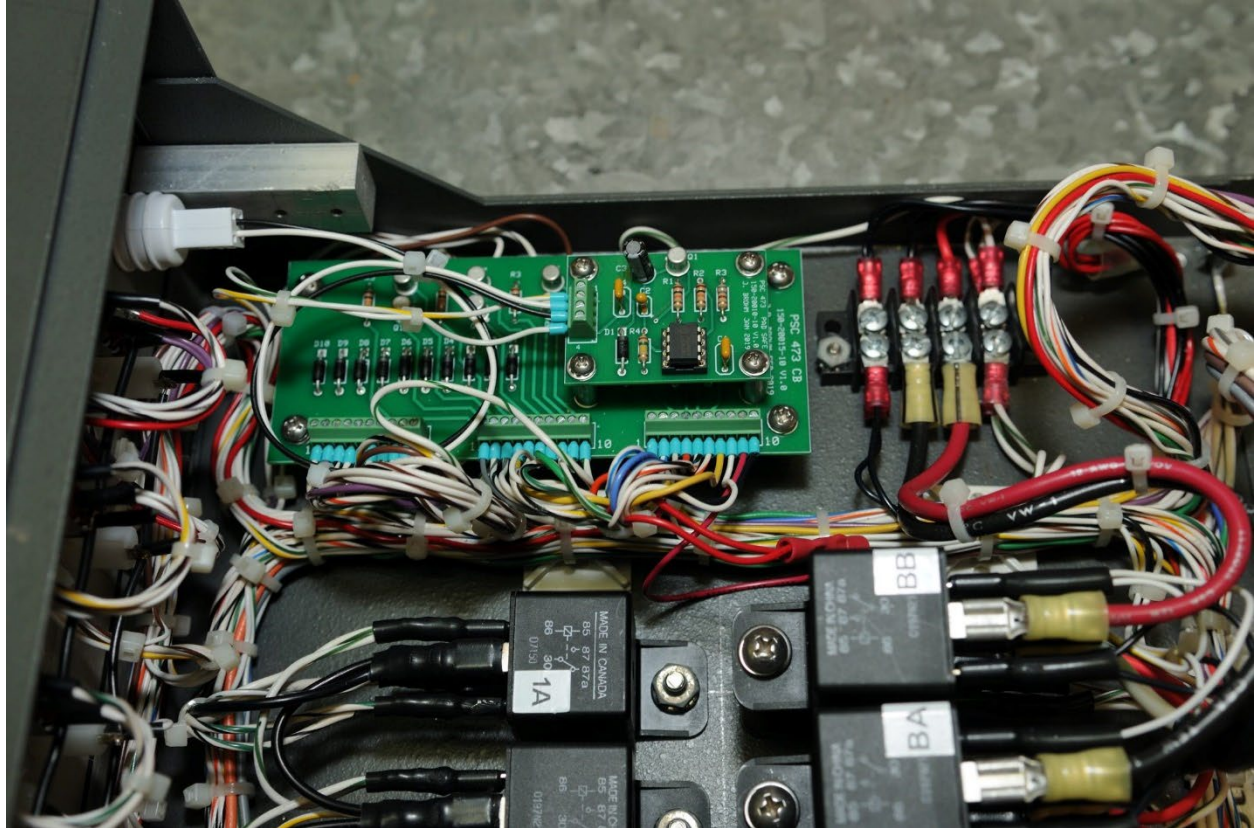
New Insides

Other than the changes to the check current limiting and input protection, all the circuits were exact copies of Tim's original design, implemented on modern professional printed circuit boards. And since these updates were made the system has performed reliably, at least until that fateful day in October 2021. What was causing the adjacent LCO Continuity Indicators to flicker? How come the flickering wasn't apparent/wasn't noticed in the operation of the old system?
